## AIRWORTHINESS DIRECTIVE

No. 2019-FATA-01020A-09

Applicability – RRJ-95 aircraft

**TECHNICAL DECISION RRJ0000-OR-470-3330**

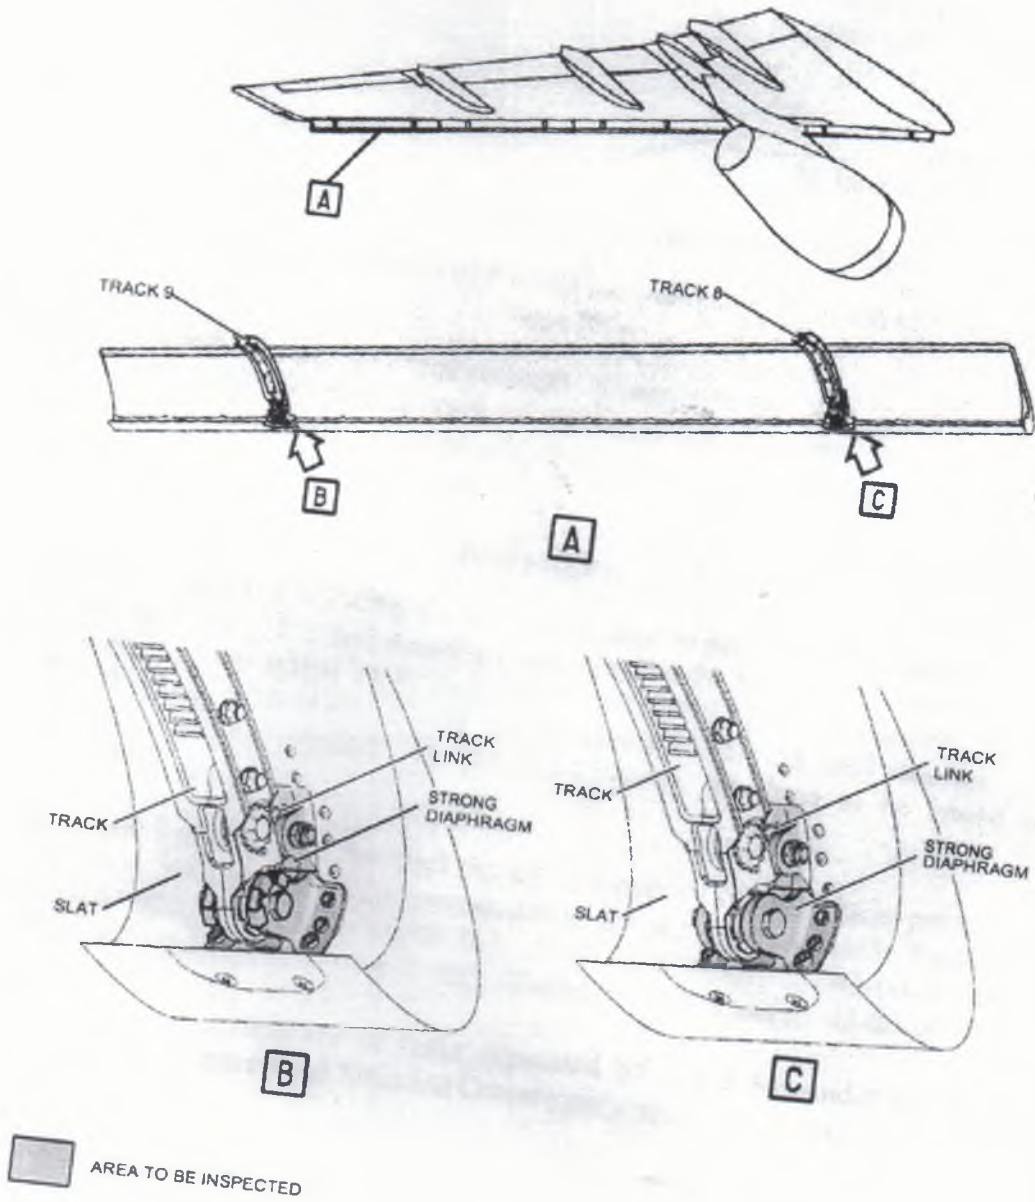
Fig.1 (For illustrative example is shown slat section 4)

during implementation of requirements prescribed by AD 2019-322-03 dd 22.05.2019 on RRJ-95 fleet a crack of slat hinge plate has been revealed. For the purposes of a prompt identification and elimination of the detected non-conformity the following decision has been taken:

1. On weekly basis of WY-Check/8 DY maintenance to perform "Detailed inspections of slat sections 1, 2, 3 and 4 strong diaphragms on the left and right outer wings" (See Fig.1) IAW AMM Tasks Nos. 57-42-00-220-801, 57-43-00-220-801, 57-44-00-220-801 and 57-45-00-220-801 on operated RRJ-95 fleet until issuance of a separate Technical Decision by the Manufacturer, which is to be issued on 15.08.2019.
2. In case of a detection of the crack during performance of the tasks as per cl. 1 – to perform replacement of the corresponding slat section IAW AMM Tasks No. 57-42-00-900-801, 57-42-00-900-803, 57-43-00-900-801, 57-43-00-900-803, 57-44-00-900-801, 57-44-00-900-803, 57-45-00-900-801 and 57-45-00-900-803.
3. The results of completion of tasks stipulated by cl.1-2 hereunder are to be reported to the Operational Situation Center [customercare@scac.ru](mailto:customercare@scac.ru).
