## **AIRWORTHINESS DIRECTIVE**

Ref. No. 2019-FATA-01020A-06

Applicability – RRJ-95 aircraft

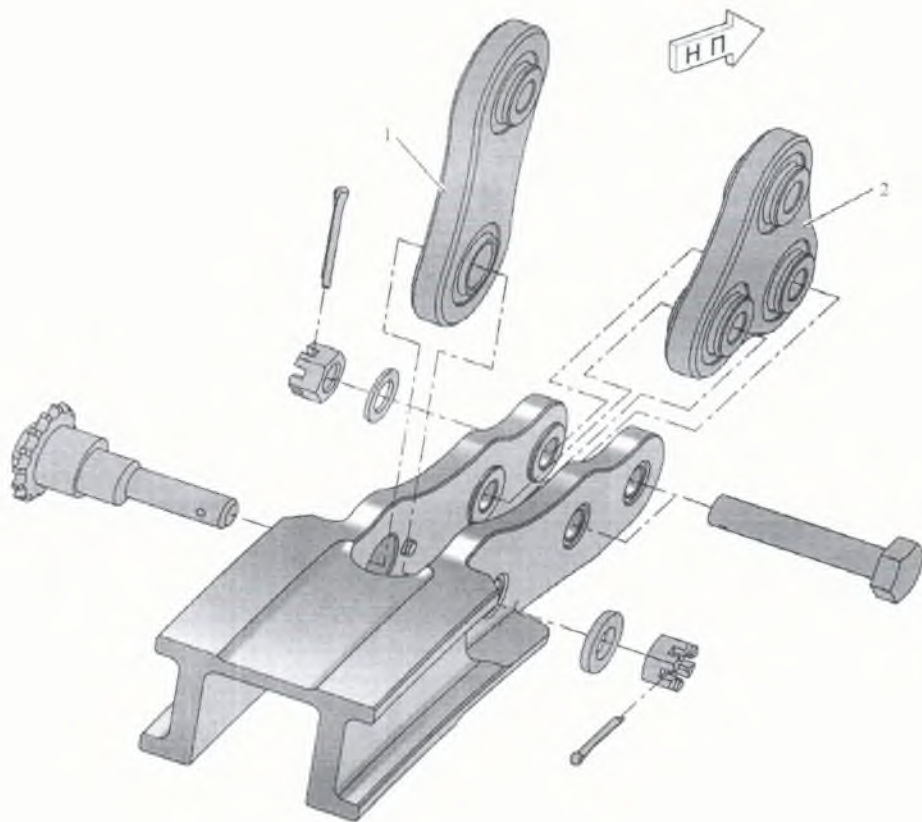
In the course of implementation of AD Nos. 2019-322-03 and 2019-322-05 on RRJ-95 A/C fleet (hereinafter – A/C) cracks on inner ring of a bearing of link of track of a slat section 1 have been revealed. In order to timely detect and eliminate the identified non-conformity as regards to link of track of a slat section

1. During the weekly WY-Check/8 DY on RRJ-95 A/C MSN 95030, 95037 and 95116-95220 to perform inspections of links of tracks (See Fig.1 (items1,2) and Fig.2 (item 3) and bearings of links of tracks of sections 2, 3 and 4 of a slat of LH and RH outer wing in accordance with provisions of p. 4. Б. (2) and (6) of AMM Tasks Nos. 57-43-00-220-802, 57-44-00-220-802 and 57-45-00-220-802 until the implementation of SB No. RRJ-57-00451-BD “Wing – Replacement of link of track of a slat section”.

3. In case of finding a crack of link of track and/or destruction and/or press-out of the bearing of link of track of sections 1, 2, 3 and 4 of a slat of LH and RH outer wing following the results of implementation of p.1 and 2 of this AD – to replace the damaged track link assembly (link of track and bearing):

- For slat sections 2,3 and 4 – to replace with the configuration of link of track of sections 2, 3 and 4 of a slat IAW identification information in Table 1 and IAW AMM Tasks Nos. 57-43-00-900-804, 57-44-00-900-804 and 57-45-00-900-804.

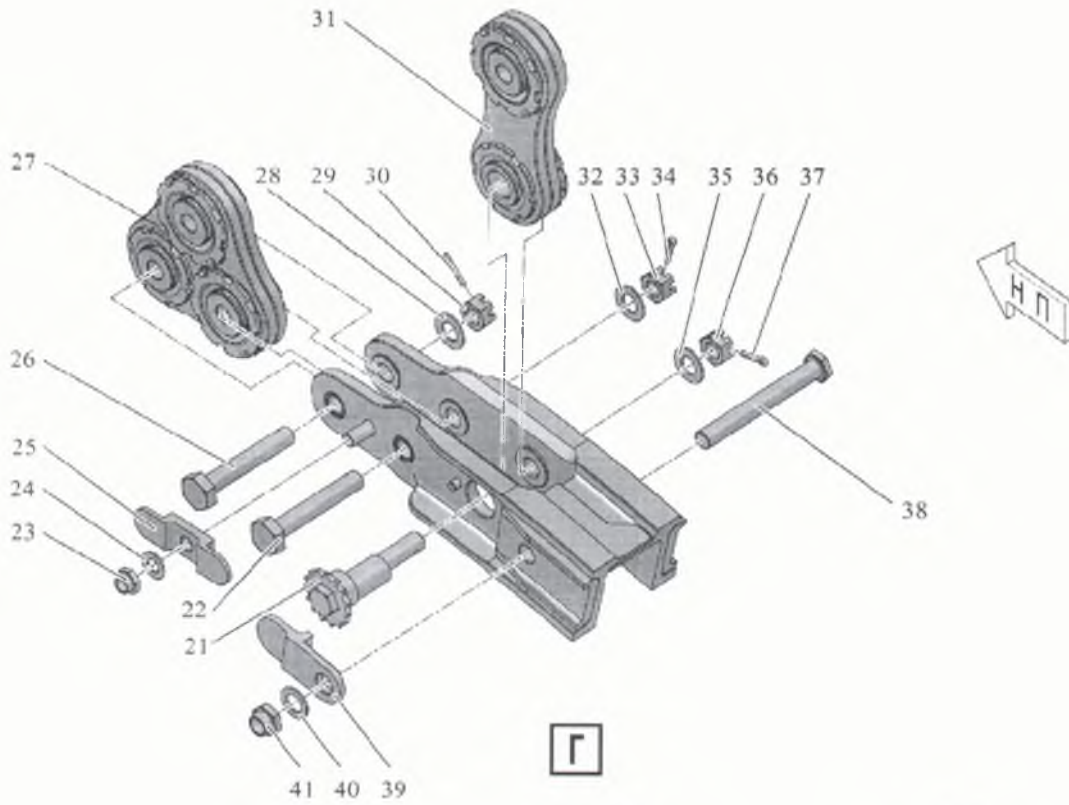
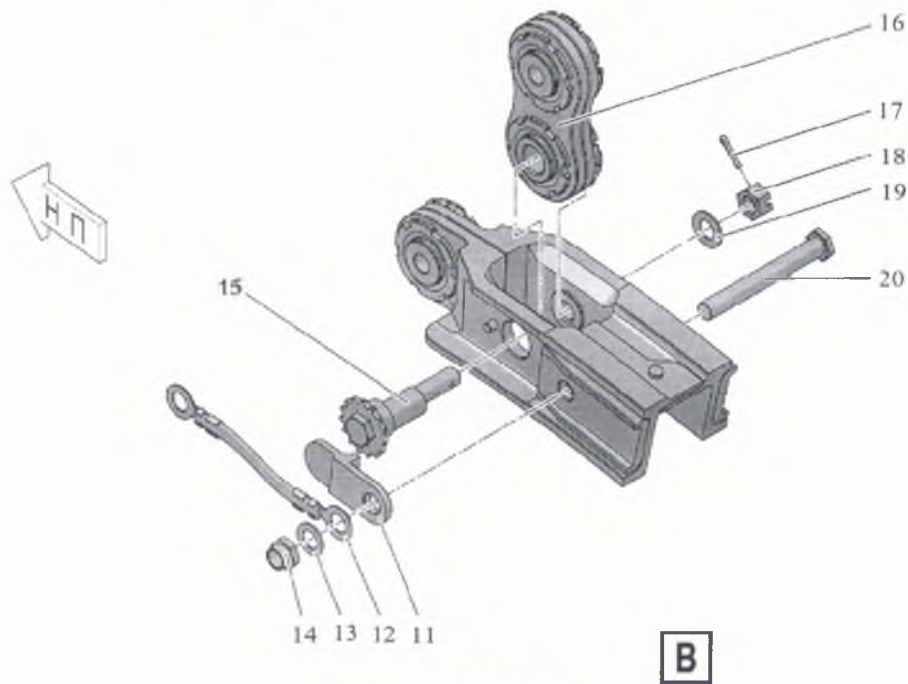
2. During the weekly WY-Check/8 DY on RRJ-95 A/C MSN 95007-95220 to perform one-time inspection of links of tracks (See Fig.3 (items16, 27 and 31) and bearings of links of tracks of section 1 of a slat of LH and RH outer wing in accordance with provisions of p. 4. Б. (2) and (6) of AMM Tasks Nos. 57-42-00-220-802.

- For slat section 1 – to replace with the current configuration of link of track of section 1 of a slat, IAW AMM Task No. 57-42-00-900-804.
