## AIRWORTHINESS DIRECTIVE

No. 2020-FATA-01020A-11

Applicability - RRJ-95 aircraft

**TECHNICAL DECISION RRJ0000-OR-470-4701**

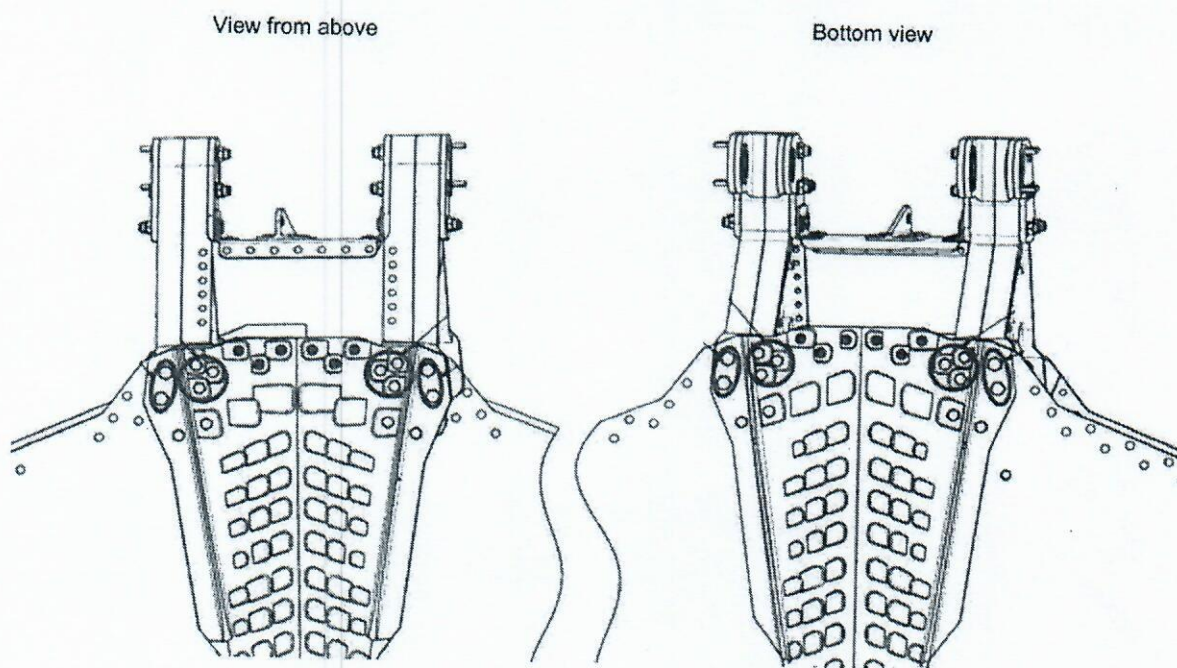
Pic.1

During maintenance of aircraft RRJ-95 fleet it was detected the damages of the bolts 8-28-И-ОCT 1 31138-80 of the stabilizer setting mechanism (further – SSM) attach bracket. The possible root case of the mentioned bolt damages are assembly stresses, due to a design flaw: on the damaged bolts there is a wedge-shaped gap between the fasteners and the surfaces of the mating parts.

1. At nearest periodic maintenance with minimum multiples: 750 FH and multiples to perform one-time inspection of the SSM attach bracket bolts iaw AMM Task 55-16-00-220-802 «Detailed Inspection of the SSM Attach Bracket and the Horizontal Stabilizer Front Spar» on aircraft RRJ-95 with operating cycles more than 1000 FC (See Pic.1);
2. The results of completion the cl.1 of this Airworthiness Directive to be sent to the address of Situations operative center of PJSC Corporation IRKUT [customercare@ssj.irkut.com](mailto:customercare@ssj.irkut.com);
3. In case of discrepancies absence during performing action related to cl.1 of the current Airworthiness Directive to continue the aircraft RRJ-95 operation with further periodic inspection of the SSM attach bracket bolts iaw AMM Task 55-

16-00-220-802 «Detailed Inspection of the SSM Attach Bracket and the Horizontal Stabilizer Front Spar» with interval 750 FH/500FC (what comes first);

4. In case of discrepancies detection during performing action related to cl.1 to follow iaw Type Certificate Holder recommendations.
5. To guide by requirements of current Technical Decision till Technical Documentation Revision or other aircraft RRJ-95 Type Certificate Holder notification.
