## TECHNICAL DECISION RRJ0000-OR-470-1975

on continued airworthiness of RRJ-95 type aircraft due to non-conformity in the mounts of passenger cabin windows retainers p/n T7.92.0704.105.000.70/B

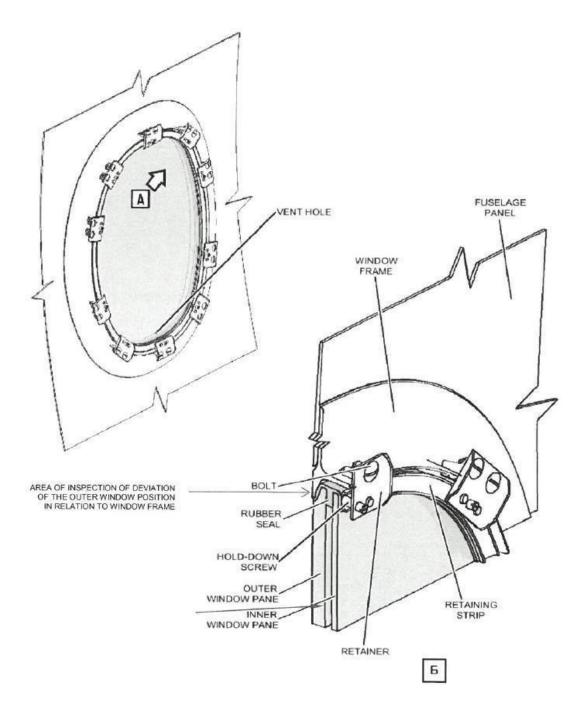
Fig.1. Passenger Cabin Window.

Due to identification of non-conformity in the mounts of passenger cabin windows retainers p/n T7.92.0704.105.000.70/B on AC RRJ-95B RA-89024 and RA-89026: loosen and fallen out hold-down screws 5-16-Xμμ.Πac.-OCT 1 31574-80, as well as loss of locking features of anchor nuts 5-Ц OCT 1 33264-89 the following decision has been taken:

- 2. In case non-conformity is revealed, upon the results of cl.1 of this Decision to perform replacement of defective mount of passenger cabin window in accordance with the procedure described below:
  - 2.1. To perform preparatory activities in order to open the access areas IAW cl.3 E. of AMM 56-21-01-900-801 "Removal/Installation of passenger cabin window";
  - 2.2. Remove seats units in the area of passenger cabin window removal (see activity AMM 25-21-01-900-801);
  - 2.3. Remove side panels in the area of passenger cabin window removal (see activity AMM 25-23-05-900-801);
  - 2.4. Perform replacement of retainers p/n T7.92.0704.105.000.70/B;
  - NOTE 2: During retainers installation instead of previously installed hold-down screws p/n 5-16-Хим.Пас-ОСТ 1 31574-80 to perform installation of new screws with hexagon head p/n 5-16-Хим.Пас-ОСТ 1 31503-80.

To perform tightening of screws IAW AMM 56-21-01-900-801. To perform tightening of screws 6 (clause 4 "B (6)", page 402) as per the following procedure: removing one-by-one each screw on the opposite sides of the strip until the gap appearance, again tighten the screws until they contact with the retaining strip. After contact to turn the screw for 1.5 of the turn, at that deformation (bending) of the corner for 1.5 mm is allowed.

- **NOTE 3:** Installation of retainers p/n T7.92.0704.105.000.70/B with the bolts p/n 5-12-Ц-OCT 1 31158-80 to be performed with application of a thin layer of paste LU-052 or sealer IS-069 on a threaded part of screws after preliminary cleaning of the contacting surface of the retainer and retaining strip (see Fig.1) with a cleaning rug soaked in solvent.
- 2.5. To apply paint-and-lacquer coating (primer ЭП-076) on the head and visible threaded part of the screw p/n 5-16-Хим.Пас-ОСТ 1 31503-80 after installation.
- 2.6. To perform test IAW AMM 21-31-00-780-801 "Test of Leakage of the Pressurized Cabin";
- 2.7. To perform final activities IAW cl.5 A. of AMM 56-21-01-900-801 "Removal/Installation of passenger cabin window".
